COMPARISON BETWEEN EXISTING INSPECTION TECHNIQUES FOR EUV MASK DEFECTS

DIETER VAN DEN HEUVEL, RIK JONCKHEERE, ERIC HENDRICKX, SHAUNEE CHENG, KURT RONSE, TSUKASA ABE (A), JOHN MAGANA (B), TRISTAN BRET (C)

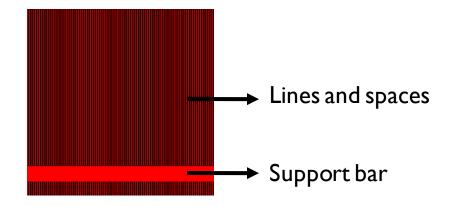
DEFECT40FF(A+B)

- Sub-modules to allow die-to-die inspection (PMI)
- Vertical lines and spaces => maximum printability
- Support bars to prevent pattern collapse

- Cell-to-cell WI is possible => WI can detect repeater defects (=reticle defects)
- Various pitch-dimensions
- Matrix of **programmed defects** (known sizes and types) to verify sensitivity of each technique

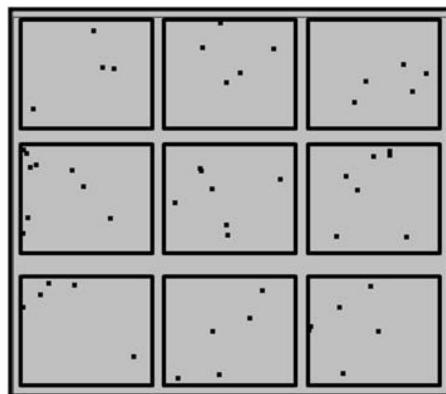
MAP (reference wafer)

48 printing defects in total

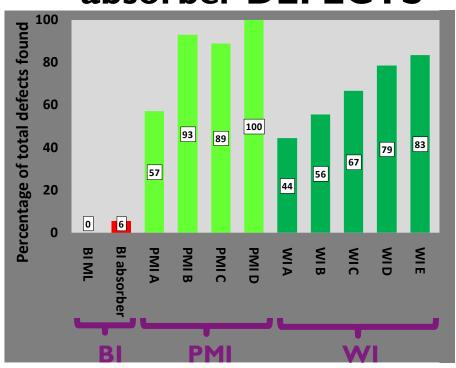
SENSITIVITY FOR ML AND ABSORBER DEFECTS SEPARATELY

100 Percentage of total defects found gap 60 88 81 67 65 45 20 31 10 12 0 PMID ¥ ≥ **≥**

Conclusion: absorber defects are more likely to be detected (and also more likely to be repairable)

=> ML defects is biggest concern

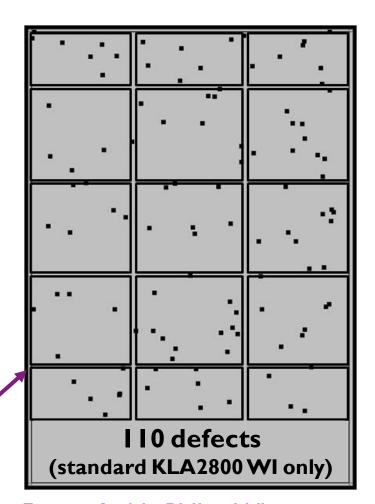
SECOND RETICLE: DEFECT40FF-A INVESTIGATION FOR ML DEFECTS

Bl after ML-deposition on Lasertec M1350

BI after absorber deposition on Lasertec MI350

BI after ML-deposition on Lasertec M7360 (= state-of-the-art)

Standard PMI with Mask vendor

KLA2800WI in IMEC

Remark: No PMI or WI on more state-of-the-art inspection tools.

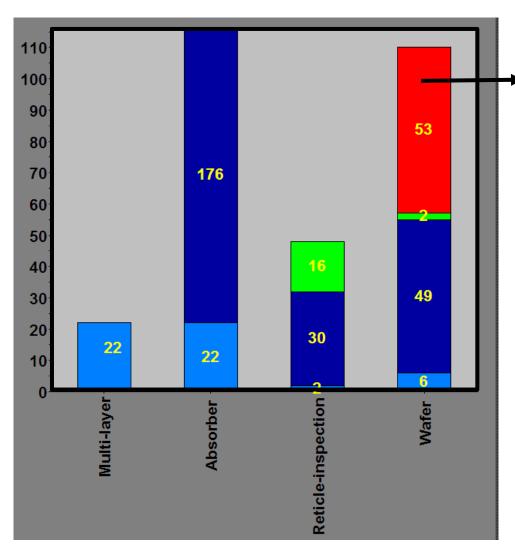
CORRELATION BI (M1350), PMI AND WI WITH DEFECT SOURCE ANALYSIS (DSA)

53 defects only found by wafer inspection => good candidates to be similar ML-defects as on DEF32

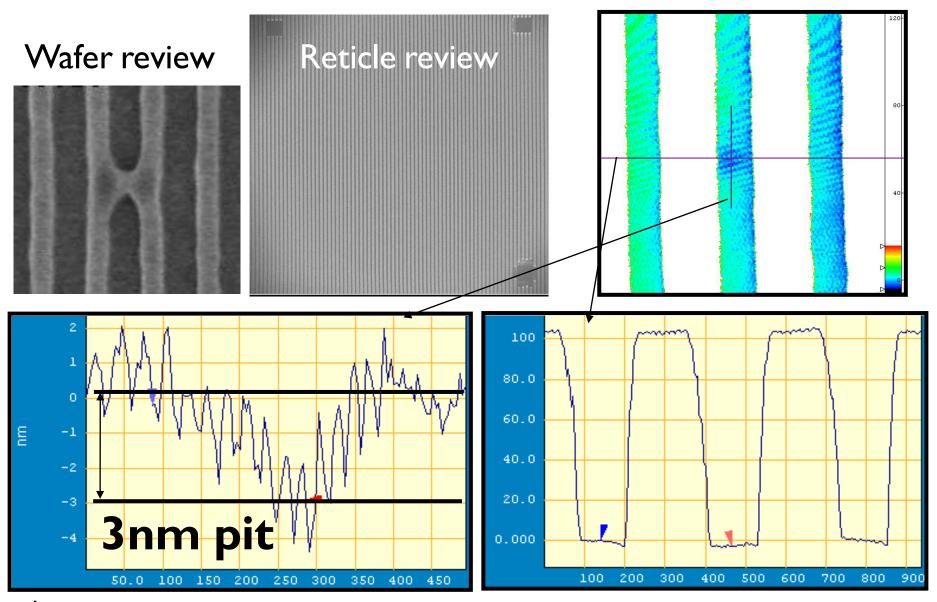
2ND ROUND OF AFM: RESULTS

Out of 21 candidate ML defects, 14 were checked with AFM and all were ML pits between 3-7nm!!

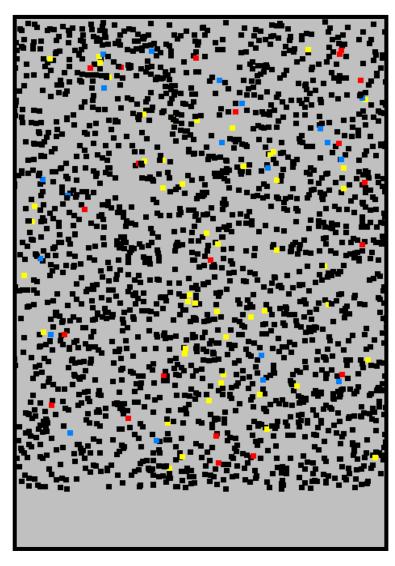
WHAT ABOUT MORE ADVANCED BLANK INSPECTION (M7360)?

- I. Did M7360 detect these 21 defects?
 - All 21 defects were detected (red dots)
- 2. Reticle review revealed not 21, but in total 41 defects that were related to ML (no focus effect).

Did M7360 find all these defects?
 - All 41 defects were detected (red + blue dots)
- 3. Review of additional detections by M7360 on wafer => how many print?
 - An additional 50 printing defects were detected (yellow dots)
- 4. Review of additional detections by M7360 on wafers => how many don't print?
 - The amount of detections of non-printing defects (black dots) is unacceptable

Note: locations were only reviewed in BF
- 5. Important remark: state-of-the-art wafer inspection tools might reveal smaller, even more-challenging ML-defects that might have been missed by M7360-inspection (future work)

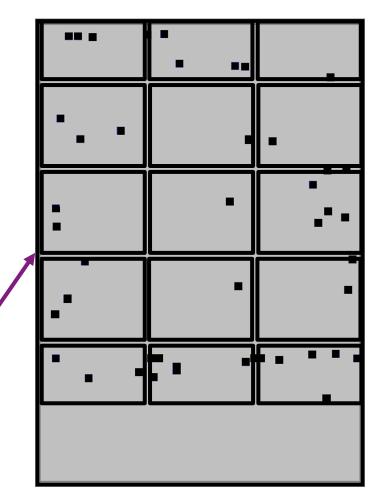
THIRD RETICLE: DEFECT40FF-B INVESTIGATION FOR ML DEFECTS

Substrate inspection on Lasertec M1350

BI after ML deposition on Lasertec M7360

BI after absorber deposition on Lasertec M1350

Standard PMI with Mask vendor

KLA2800 WI in IMEC

Optimized WI procedure on more state-of-the-art WI-tool

KLA2800:27 defects

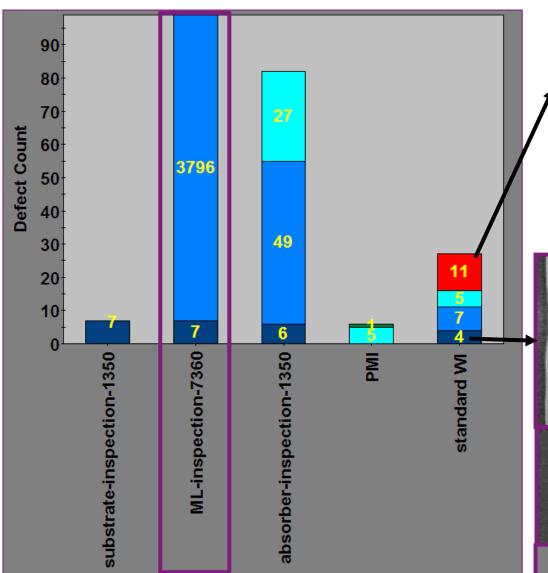
DEFECT40FF-B: DSA RESULTS

- Mostly particles, I-2 defects with minor focus behavior
- What if we try to improve WI?

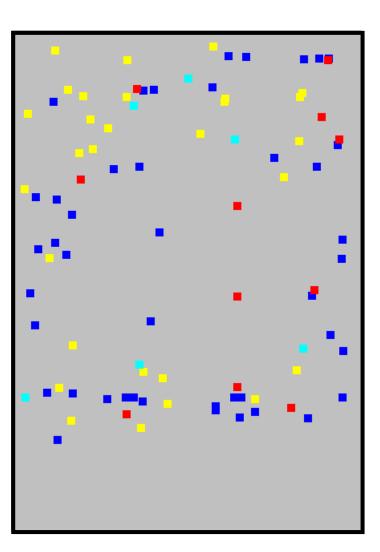
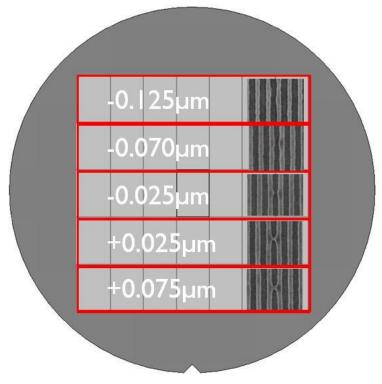
IMPROVEMENT OF WAFER INSPECTION TECHNIQUE

KLA 2800 WI in best focus (BF)

KLA2800 WI on focus-skew wafer

Advanced WI (AMAT UVI 4) in BF
Advanced WI (AMAT UVI 4) on focus-skew

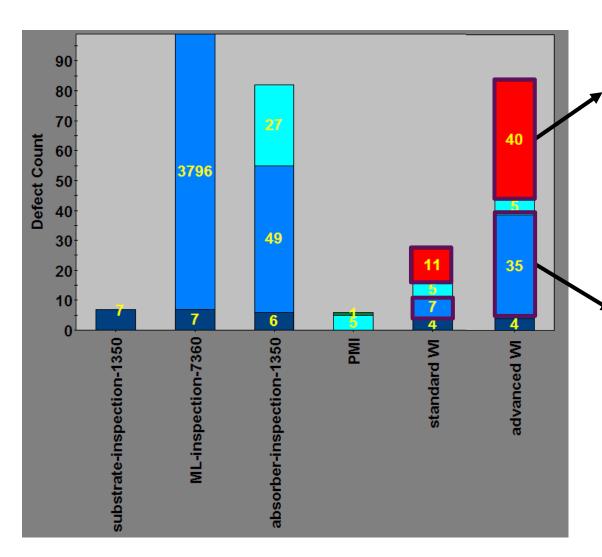
DEFECT40FF-B: DSA WITH OPTIMIZED WI

Nr. of defects only found by WI also increases significantly

Number of defects correlating with BI increases significantly

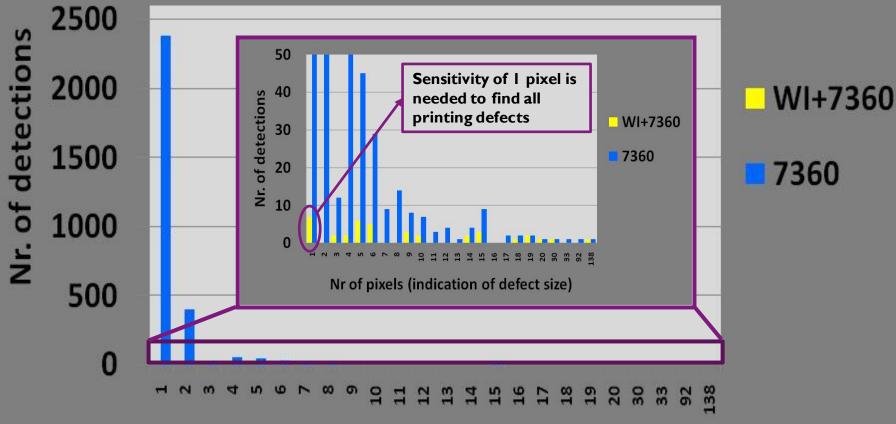
NUISANCE RATE M7360

Is it possible to remove nuisance defects without loosing real printing defects?

Nr of pixels (indication of defect size)

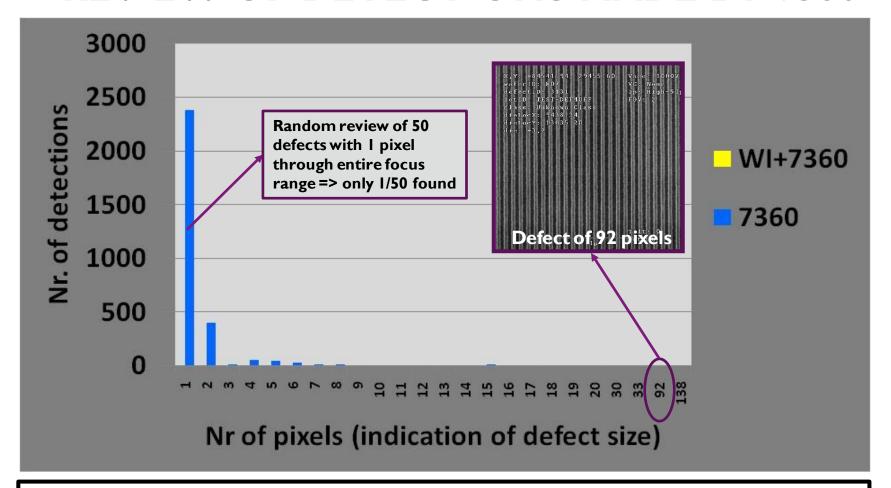
REVIEW OF DETECTIONS MADE BY 7360

Major challenge for optical blank inspection will be to differentiate between defects that are likely to print and defects that are not likely to print
